# Dannevirke Raw Water Reservoir

## Stage 2 Geotechnical Interpretation Report

**Prepared for**  
Taranua District Council

**Prepared by**  
Tonkin & Taylor Ltd

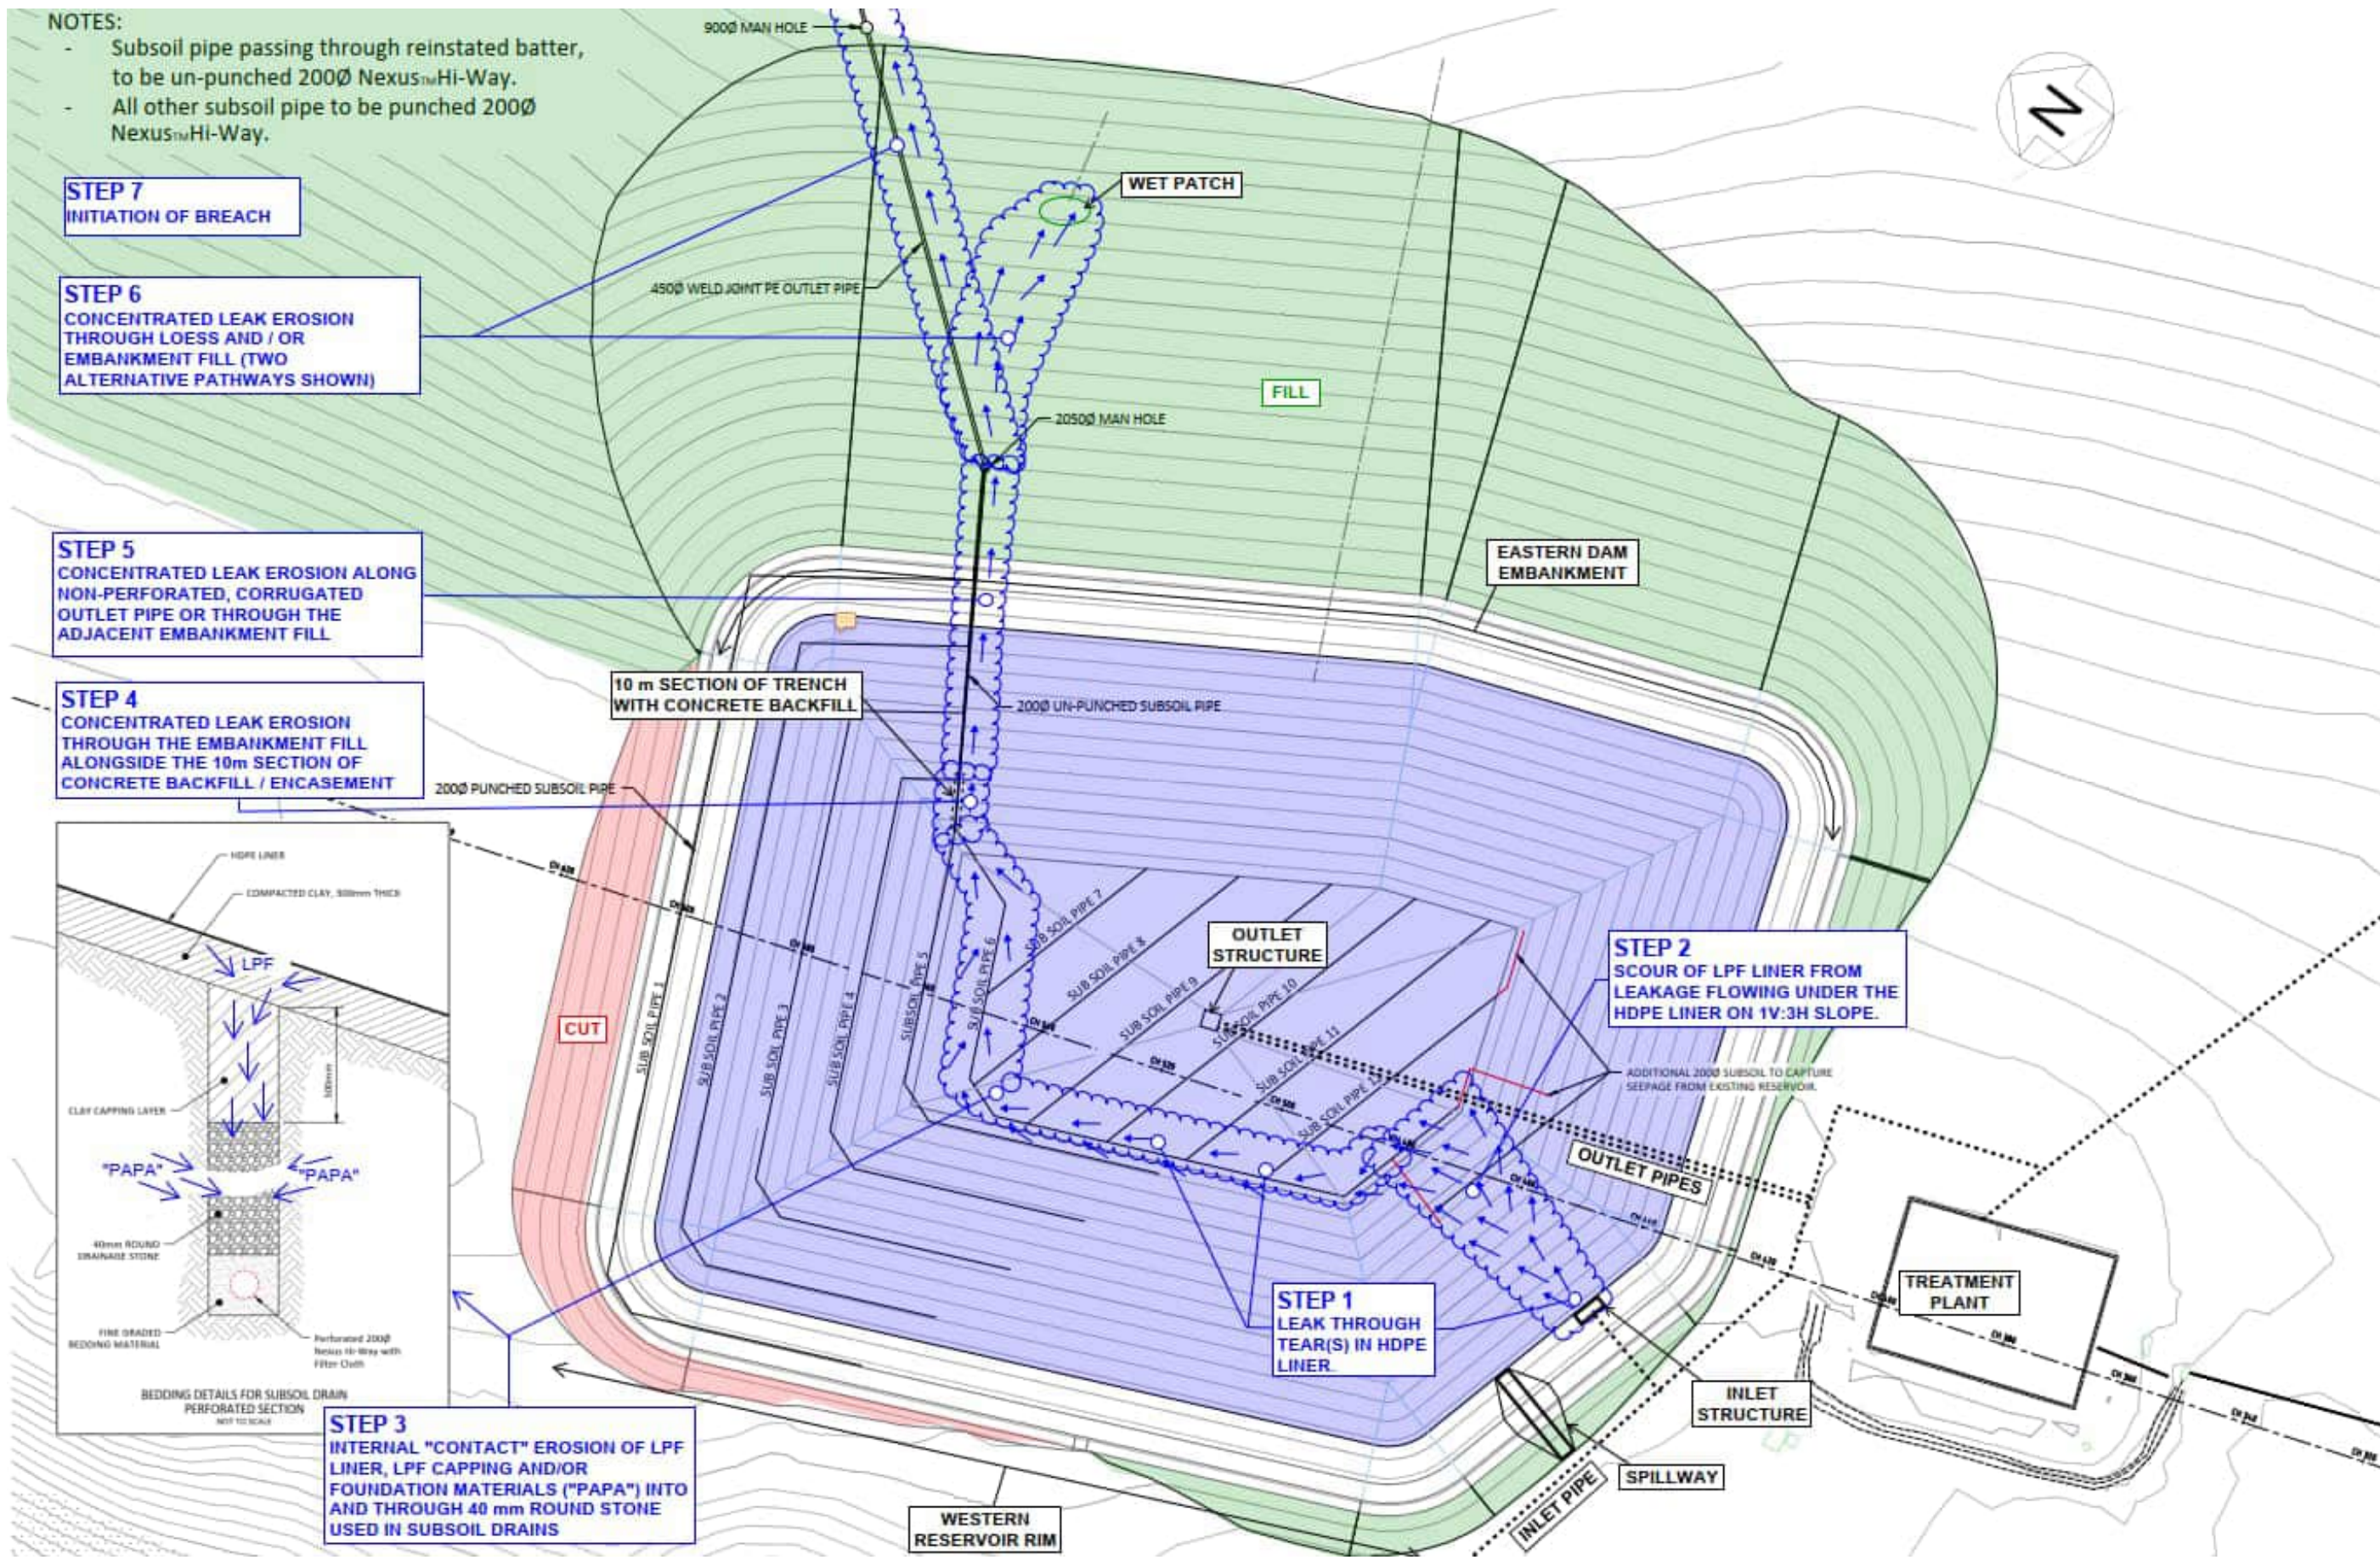
Figure 0.1: Steps in postulated failure mode for subject dam safety issue

A sequence of steps that could lead to an uncontrolled loss of reservoir contents, or “potential failure mode”, was identified in relation to this deficiency. The steps in the potential failure mode are presented in Figure 0.1. Step 3 in this potential failure mode is known to be continuing to deteriorate. There are identified vulnerabilities to other steps in the potential failure mode, but initiation and progression of these other steps remains unavoidably uncertain.

Issue “d” is included in this report because it is relevant to TDC’s decisions on timing of remedial works. We note also that issue “c” and “d” together cover most of the steps in the potential failure mode in Figure 0.1, which is the core focus of the remedial design. Issue “d”, specifically, relates to those steps in the potential failure mode that are known to have occurred and are visibly continuing to deteriorate.

- Issue “d” and the associated potential failure mode (Figure 0.1) represent the greatest risk for dam safety. As such, repairing the liner, subgrade, and subsoil network should remain the central and urgent focus of the remedial works. It is considered possible that the existing situation could deteriorate rapidly and require emergency intervention at any time. This would likely require dewatering and take the reservoir out of service for water supply to Dannevirke. The longer the repair of the liner, subgrade, and subsoil network is deferred, the greater the risk that an emergency could arise that could affect water supply to Dannevirke. Therefore, we recommend preparing to remove the risk as soon as practicable either by repairing the liner, subgrade, and subsoil network or decommissioning the dam.

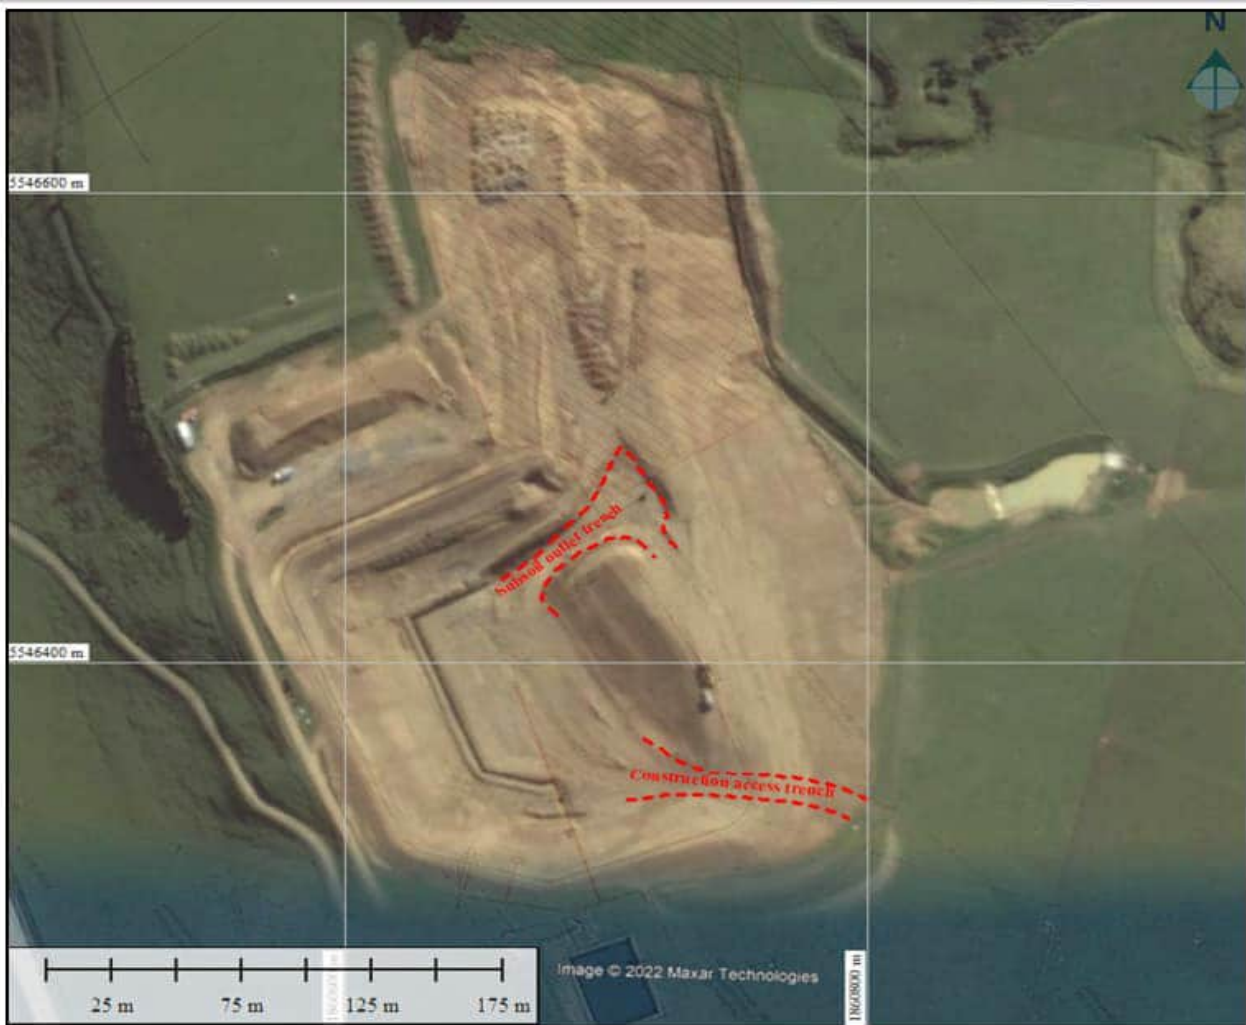
Figure 3.1: Deep trenches cut through eastern fill embankment during construction (photo dated 23 August 2012, taken from Google Earth, overlaid on as-built drawing sheet 2)
