Dannevirke Impounded Supply

Public Meeting
28 November 2023

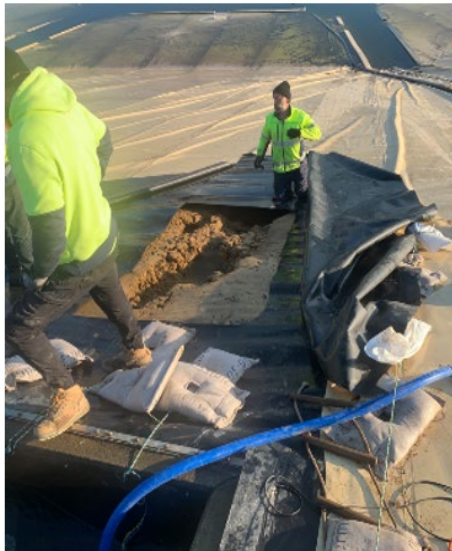
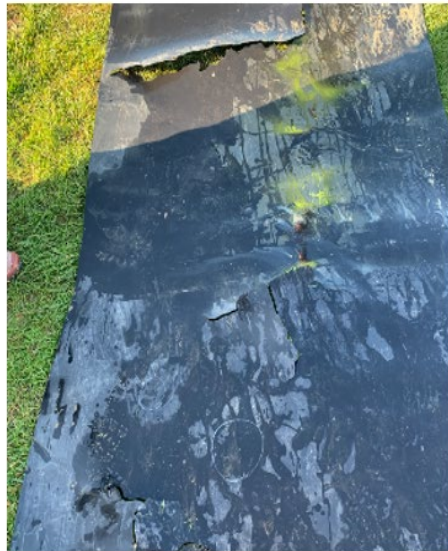
Initial Leak

July 2021 to September 2021.

- Subsoil outlet flows increased
- Reservoir level started dropping
- After floating cover removed, HDPE liner found to be “shredded” near the inlet
- The damaged liner below the inlet was repaired.
- ROV inspections found depressions under the HDPE liner:
 - On the slope below the inlet
 - At two locations on the reservoir floor
- Elevated level of water loss continued

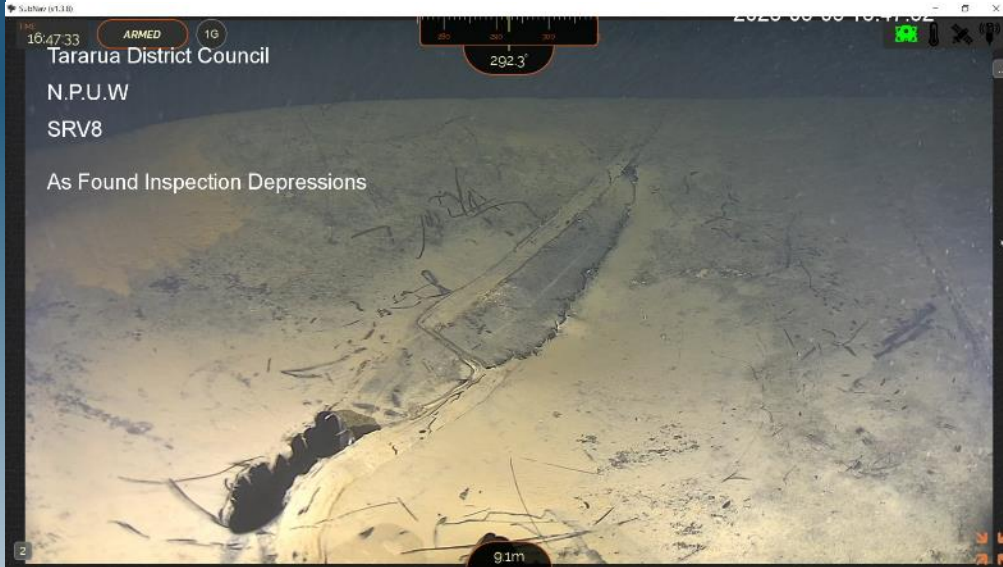
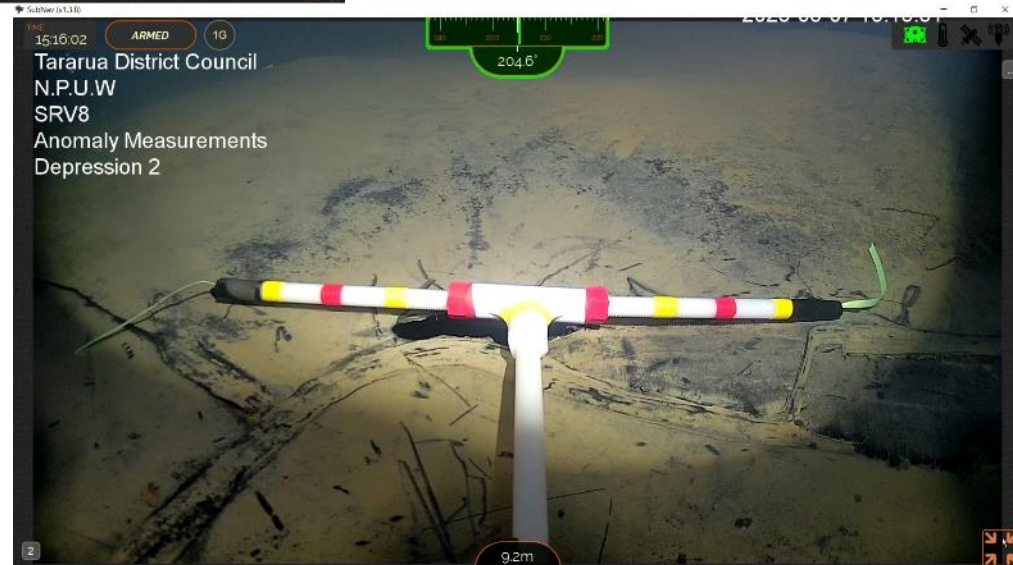
Subsequent Leaks

Two tears located in May 2023

The liner around the 2 tears was cut out and the cavity which had formed below was filled with sand, after which a specially designed patch was sealed onto the existing liner.

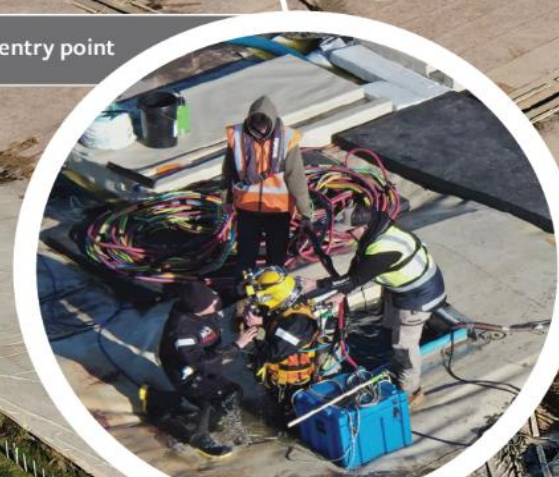
This is the dam's cover which protects the impounded water below it.

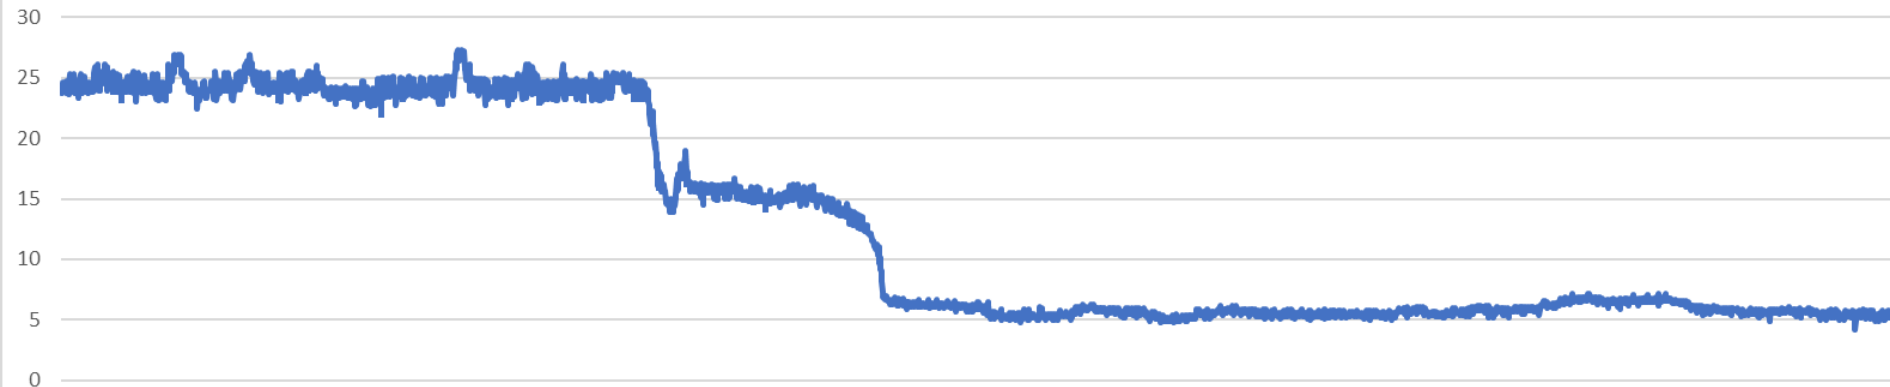
Impounded Supply Subsoil Drain Discharge Flow Rate (l/s)
10 June - 26 June 2023

- Minor ongoing deterioration of internal depressions
- No deterioration of the eastern embankment (“dam wall”) identified
- Subsoil drain outlet flow has reduced from ~25 litres per second to ~3 litres per second
