Forbes Ecology

**Attn: Duncan and Susie Cheetham**

## **BACKGROUND**

Forbes Ecology Limited was engaged by Duncan and Susie Cheetham to evaluate the nature and extent of RMA (1991) section 6c matters as they relate to their property on the southern boundary of Rongotea, Manawatu. On site it soon became clear that the issue needing investigation was the status of land regarding the Freshwater National Policy Statement definition of Natural Inland Wetlands.

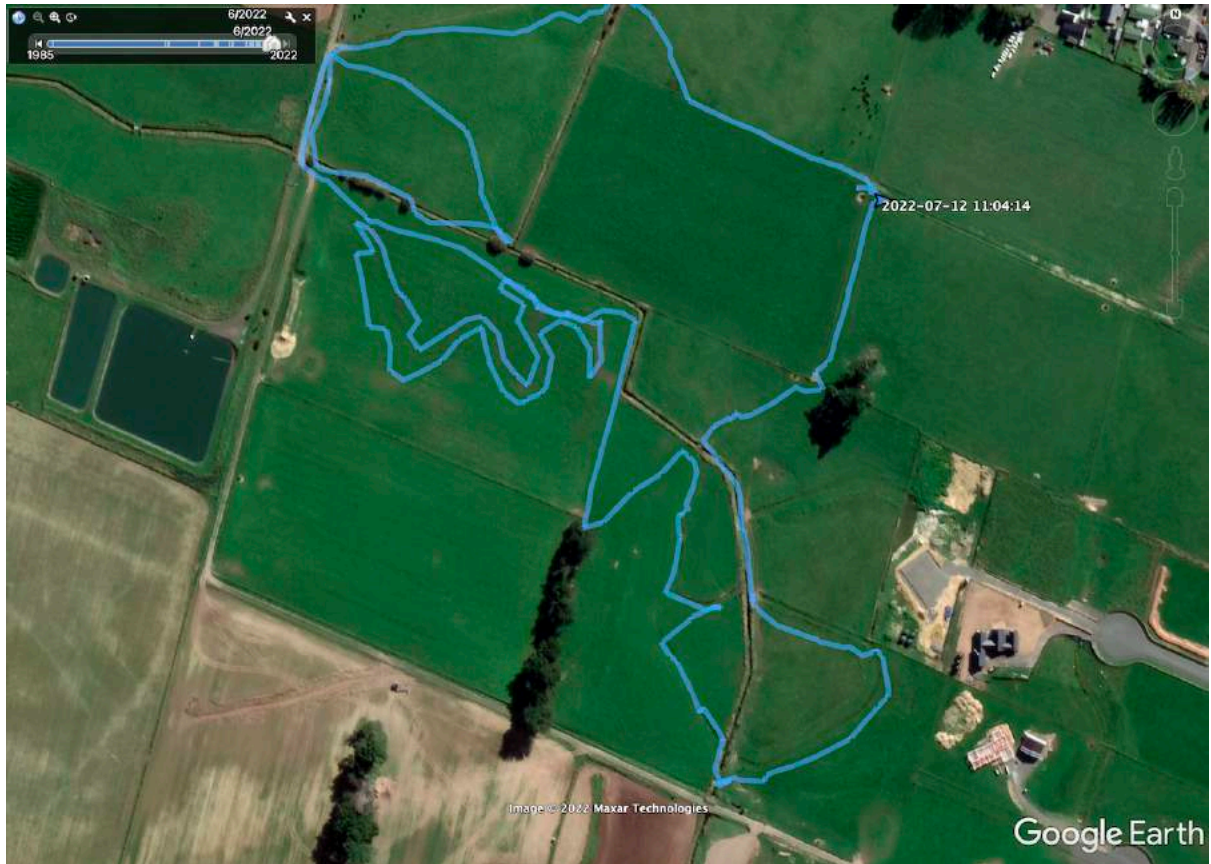
Figure 1. Site visit track log from handheld GPS.

The site visit route was plotted using a handheld GPS (Fig. 1).

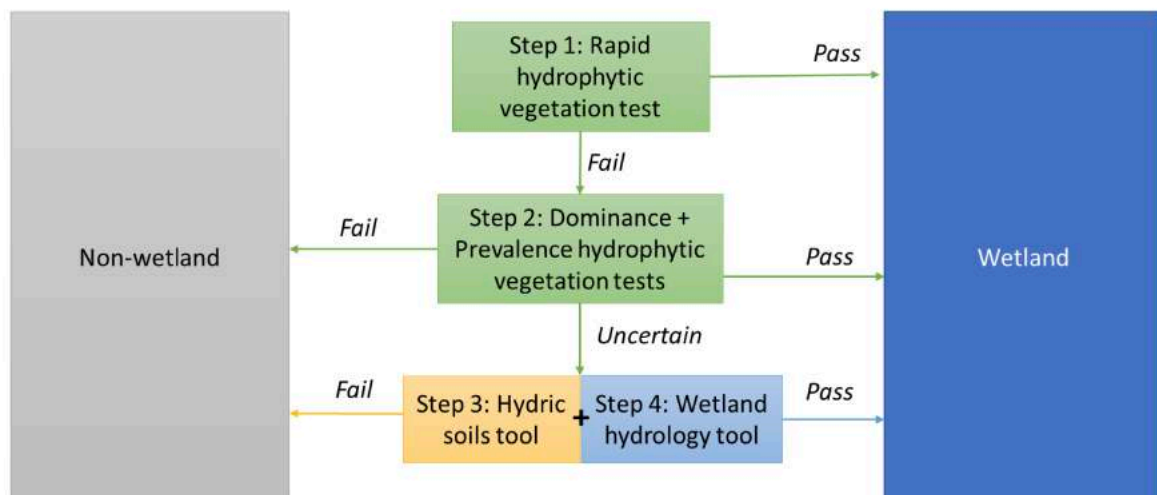
Figure 2. MfE's four steps for delineating wetland using the hydrophytic vegetation, hydric soils and wetland hydrology tools.

Wetland delineation was carried out subsequently using the following approach (Fig. 2) and tools.

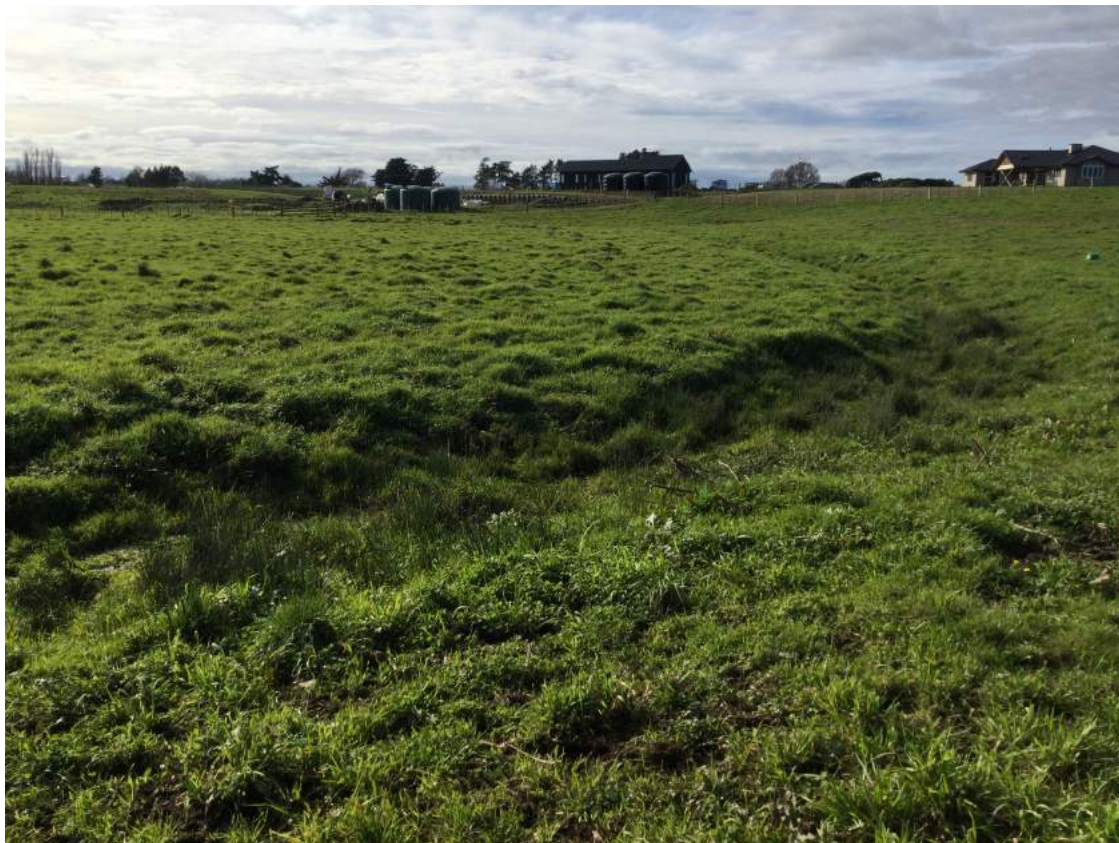
Figure 3. Native rushes colonising artificial drainage channel to the east of the site.

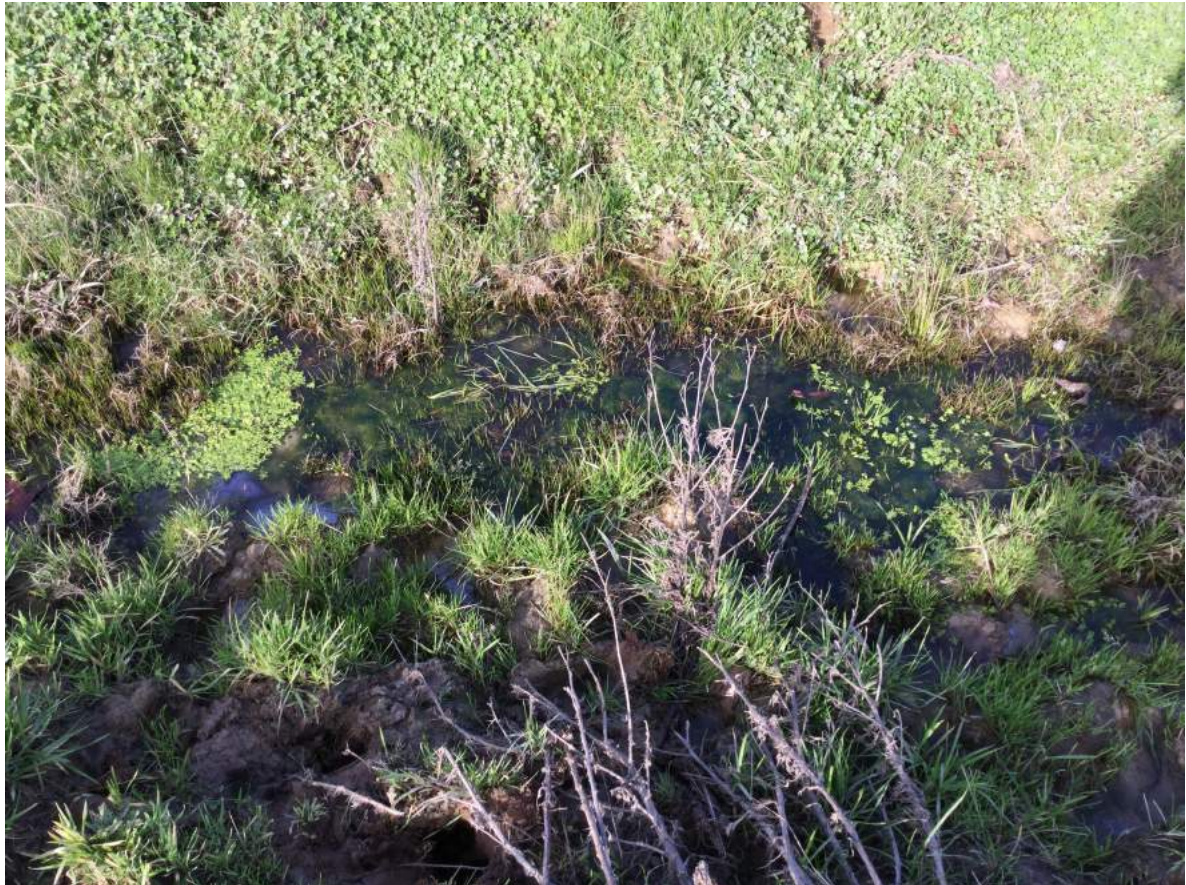
Examination of Google Earth Pro imagery over the period 2004-2022 confirms that the vegetation cover of the land, in particular the valley floor, have a history over many decades of pastoral grazing and cultivation. Surface drains have been formed over the south eastern portion of the site. Colonisation of wetland vegetation appears to have been limited by the disturbance associated with grazing animals and pasture management/cultivation. This means only small areas of native rushes (*Juncus australis* FACW and/or *J. effusus* FACW) occur in drainage channels (Fig. 3). These rushes are palatable to stock and are heavily grazed. Other aquatic flora present in drains are duckweed (*Lemna minor*; OBL; Fig. 4) and green filamentous algae (Fig. 4).

Figure 4. Duckweed and green filamentous algae in one of the artificial drainage channels.

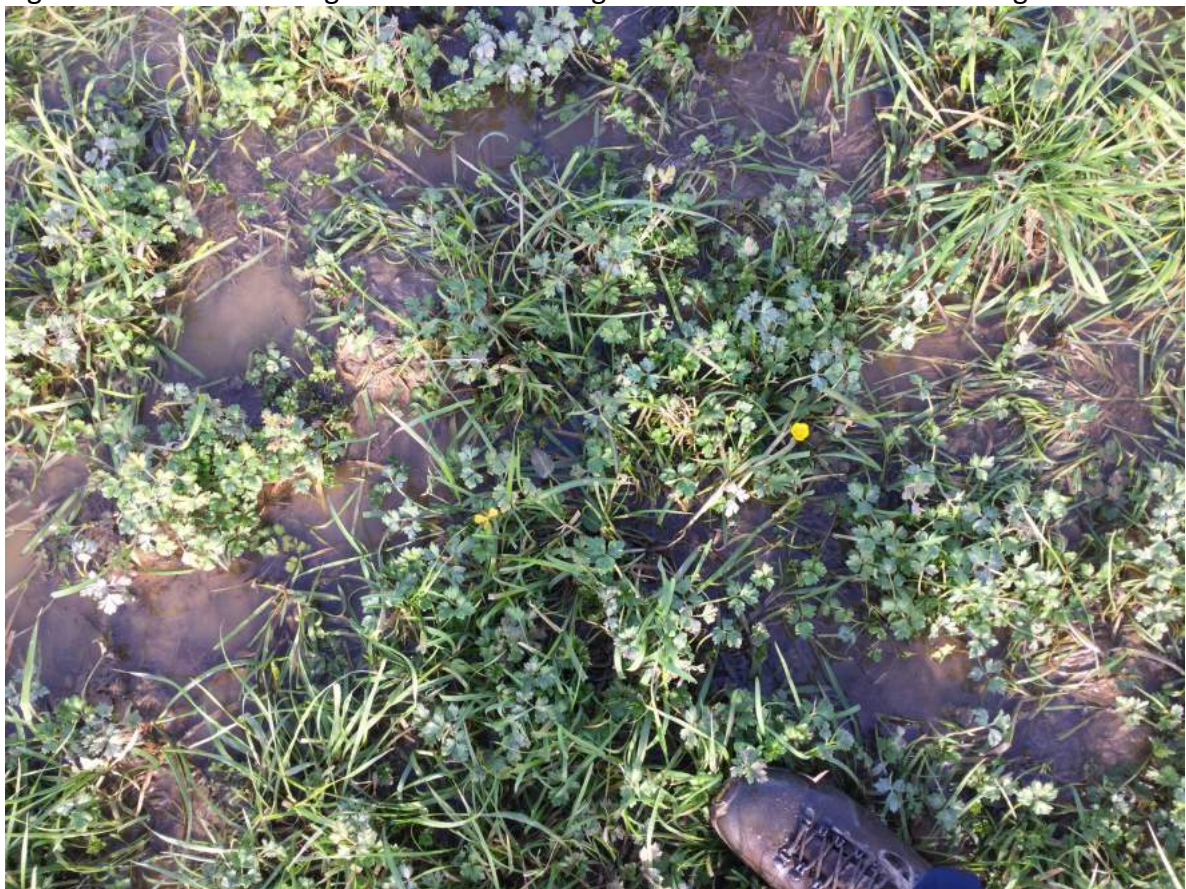
Wet areas of pasture comprise up to approximately 30% cover of creeping buttercup (*Ranunculus repens*, FAC) and no obligate (OBL) or facultative wetland (FACW) flora (Figs. 5-7). The absence of wetland flora would be a result of disturbance from pastoral land use.

Figure 5. Creeping buttercup and exotic pasture grass growing in a waterlogged site.

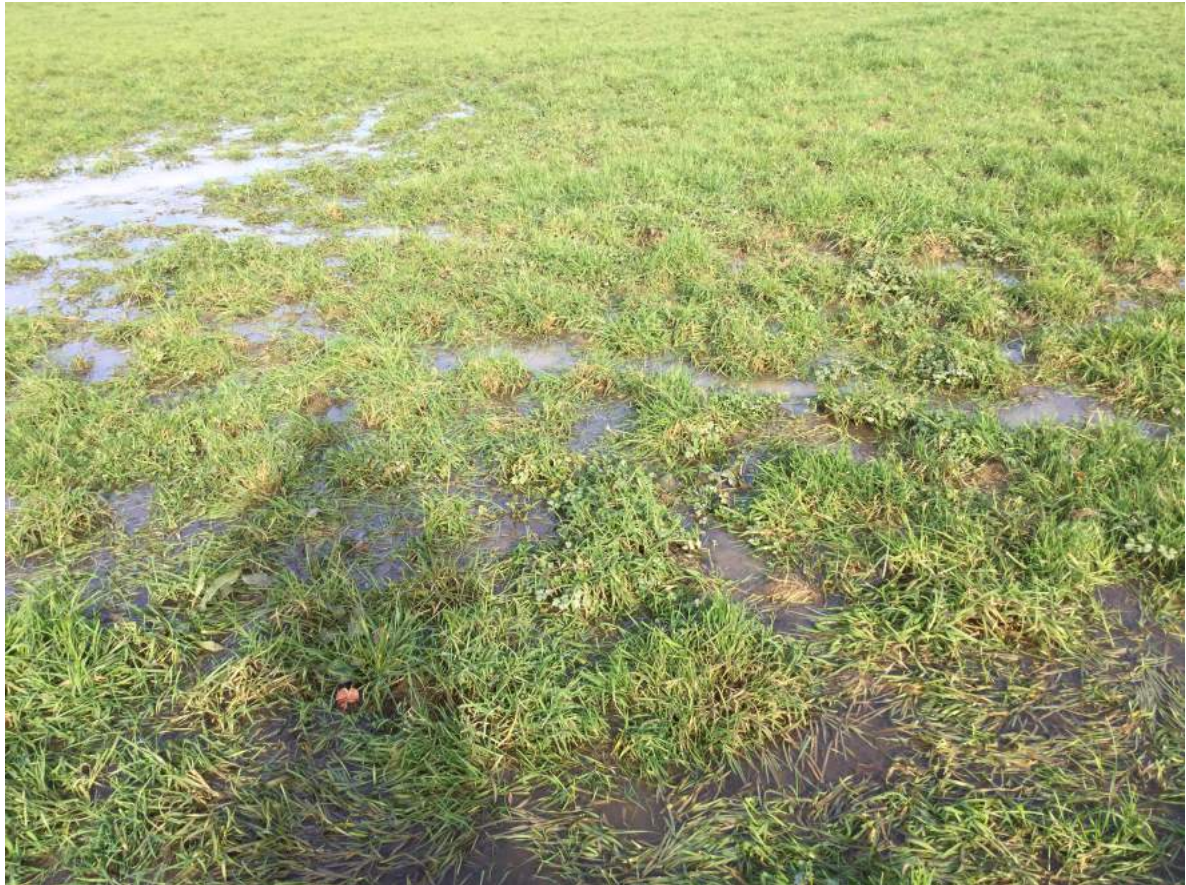
Figure 6. Surface ponding amongst pasture.

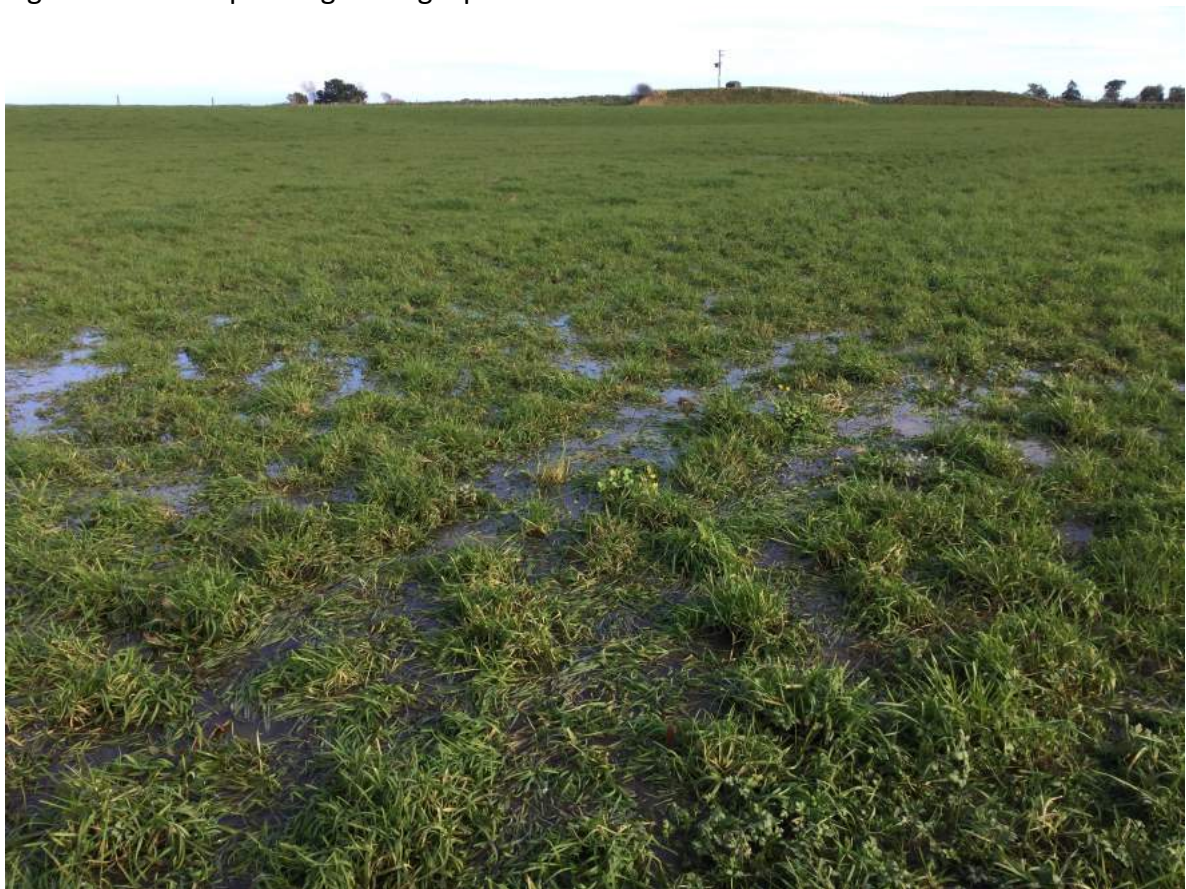
Figure 7. Surface ponding amongst pasture.

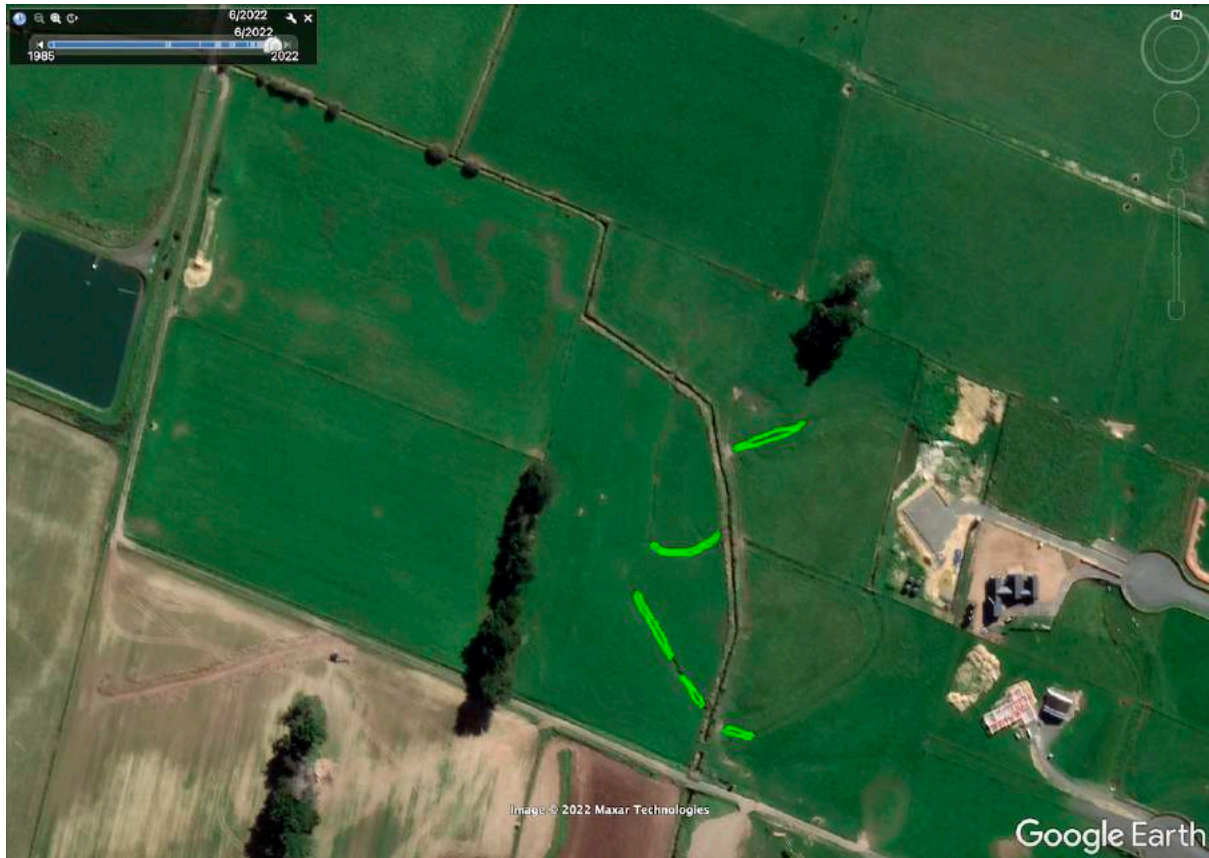
Overall, obligate (OBL) or facultative wetland (FACW) flora are confined to drainage channels and make up only a small area of coverage (Fig. 8).

Figure 8. Approximate extent of native wetland vegetation.

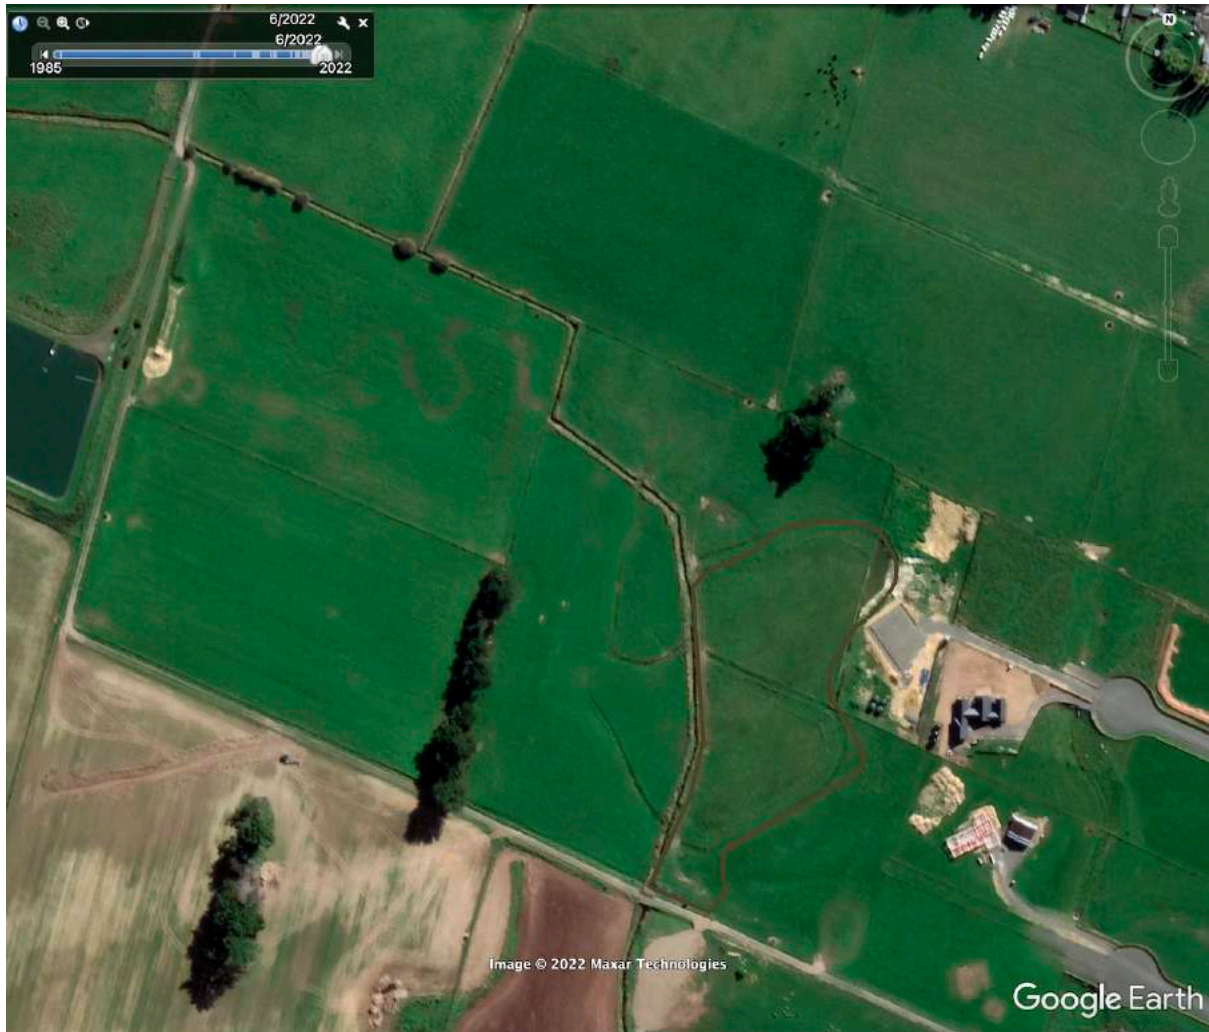
An investigation (Hainsworth, 2022) into the soil characteristics of the terrace systems determined the valley floor (alluvial basin; brown polygon in Fig. 9) on the true left of the stream (at the south east of the site) features peaty soils (see Fig. 5 in Hainsworth, 2022) and a rising water table near the surface causes very poor drainage. These organic soils indicate a long history of wetland vegetation colonising the site in pre-human times. These wet organic soils are hydric soils.

Figure 9. Extent of peaty organic soils transposed from Hainsworth (2022).

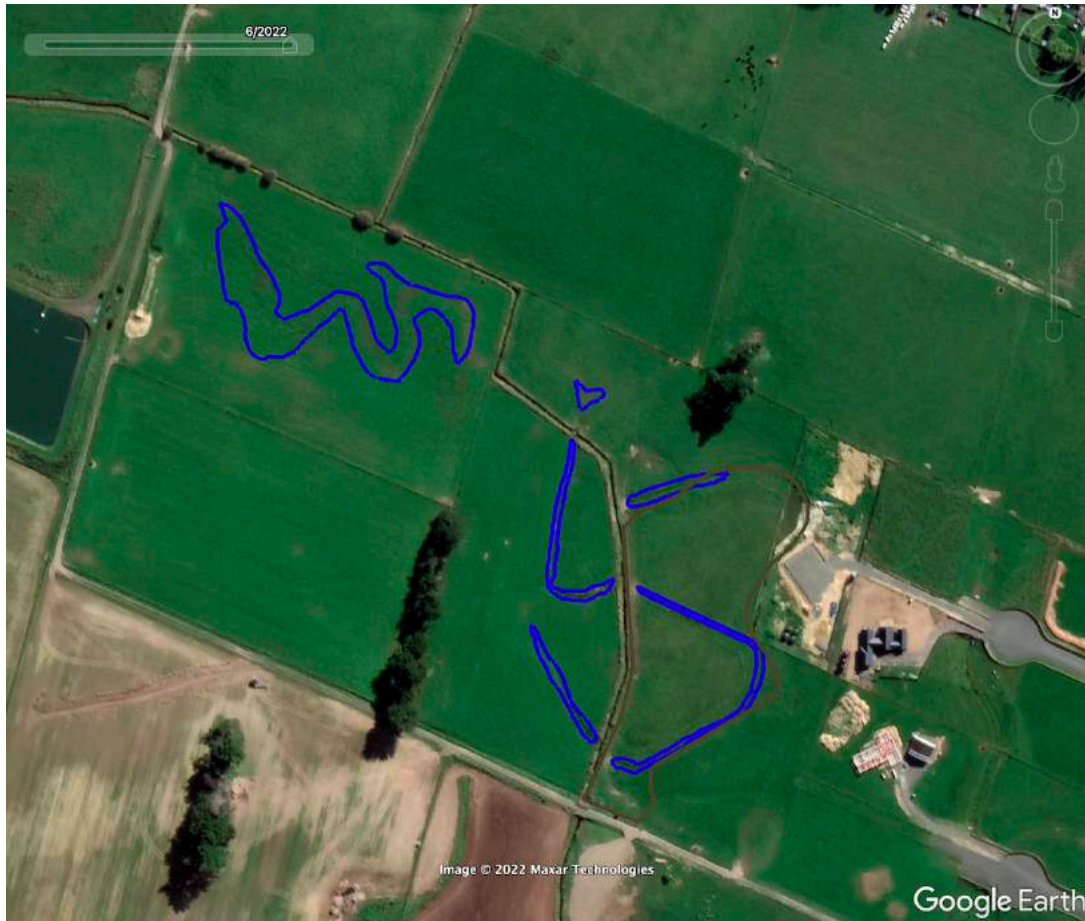
Other areas of valley floor are low lying and receive runoff from higher ground. Surface ponding was widespread at the time of the site visit (Fig. 10). The soil surface was in places pugged and featured wheel track depressions from a 4WD previously passing over (Fig. 11). A relict stream channel is present on the true right south of the T-shaped convergence in the existing drain. Artificial drains have been formed elsewhere on the true right of the valley floor. Hainsworth (2022) reports soils in these valley floor areas<sup>2</sup> to be Typic Perch-Gley Pallic (shallow)<sup>3</sup>. Cores appear low chroma and iron residues were noted 25-45 cm below ground level (Hainsworth, 2022).

Figure 10. Extent of surface ponding at the time of the site visit.

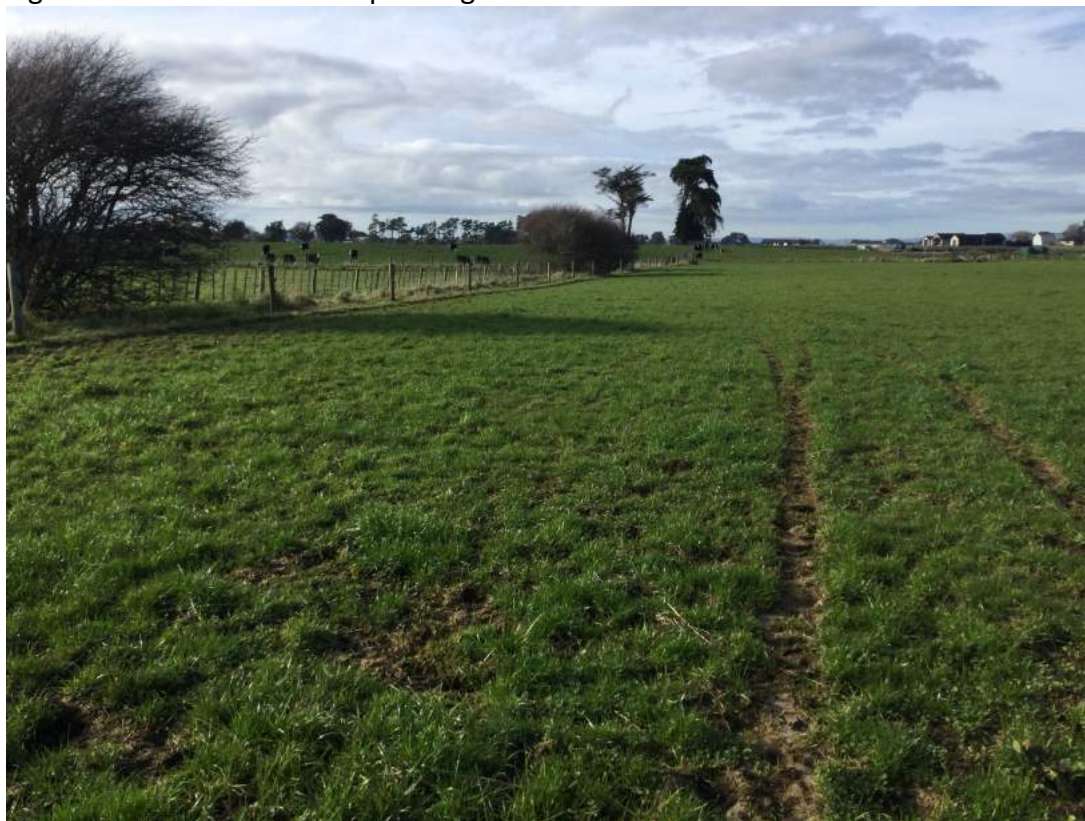
Figure 11. 4WD tracks across waterlogged soils on the valley floor.

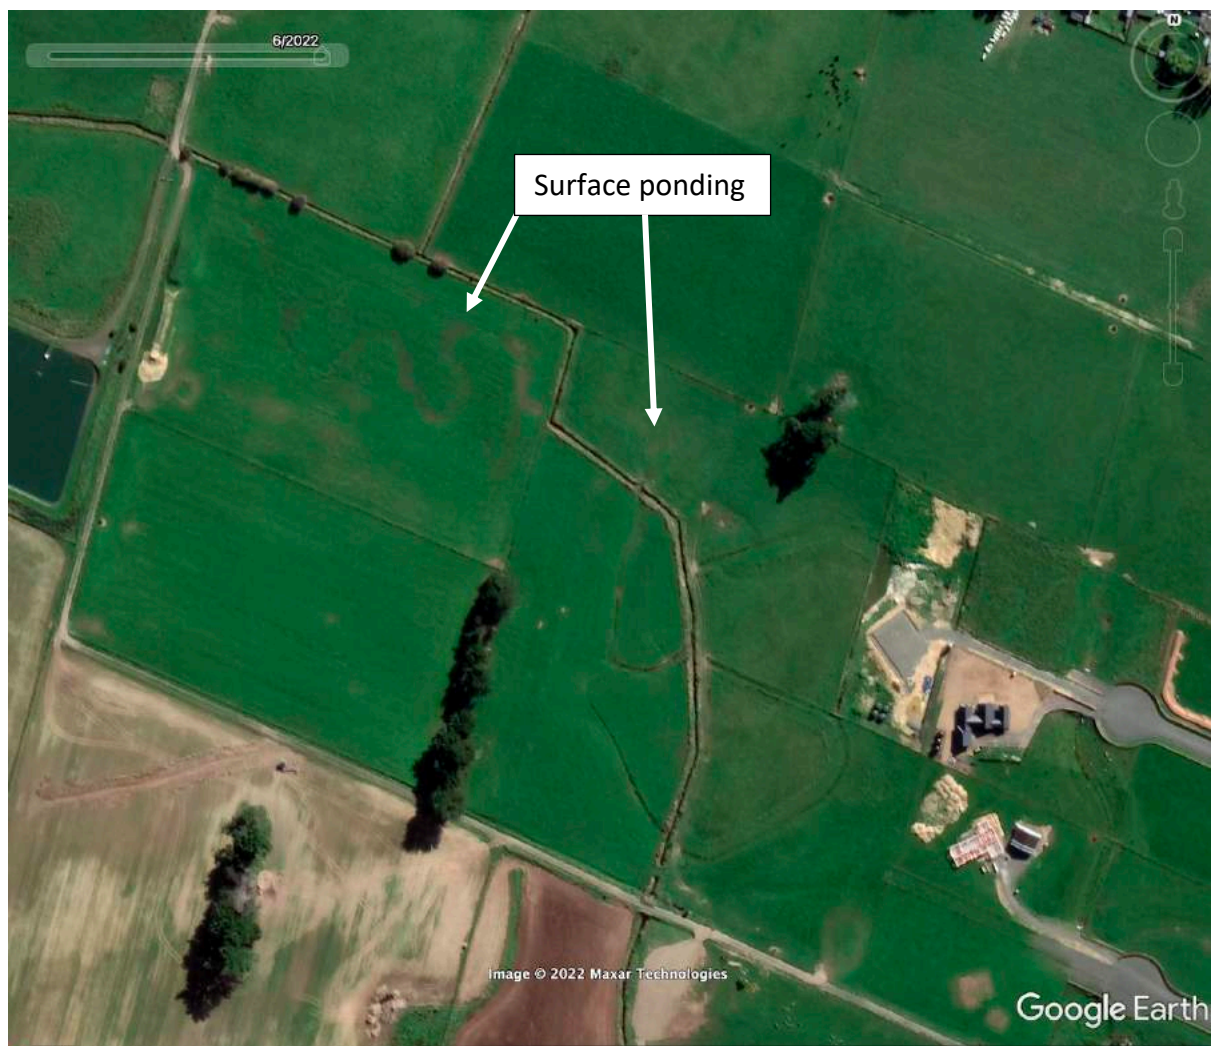
Site assessment of hydrology indicators showed that extensive areas of the valley floor had surface water ponding (a primary indicator confirming wetland presence). The soil types present indicate prolonged soil saturation (a primary indicator confirming wetland hydrology). Reduced iron is present within 30 cm of the soil surface, inundation is visible on satellite imagery (Fig. 12), the geomorphic position of the valley floor is predisposed to forming wetland conditions and relict flow paths are discernible on the ground surface. Each of these characteristics are secondary indicators of wetland hydrology.

Figure 12. Google Earth Pro imagery showing surface ponding in former waterway alignments on the valley floor.

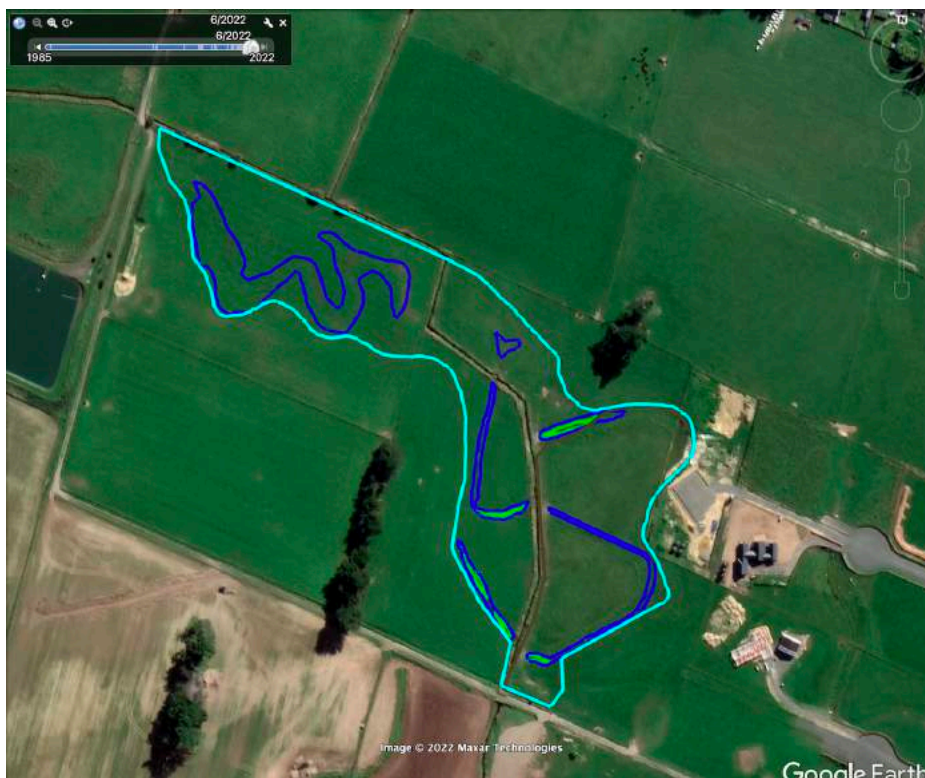
Application of the three wetland delineation tools has resulted in delineation of 3.96 ha of natural inland wetland (light blue perimeter in Fig. 13).

Figure 13. Natural inland wetland extent (light blue line) with areas of noted surface ponding (dark blue line), native wetland vegetation (green fill) and peaty soils (brown line).

Restoration of the natural inland wetland is encouraged. Restoration should involve active interventions and management to restore the natural hydrology and reinstate swamp vegetation across the site.
