# Dannevirke Raw Water Reservoir

## Stage 2 Geotechnical Interpretation Report

**Prepared for**  
Taranua District Council

**Prepared by**  
Tonkin & Taylor Ltd

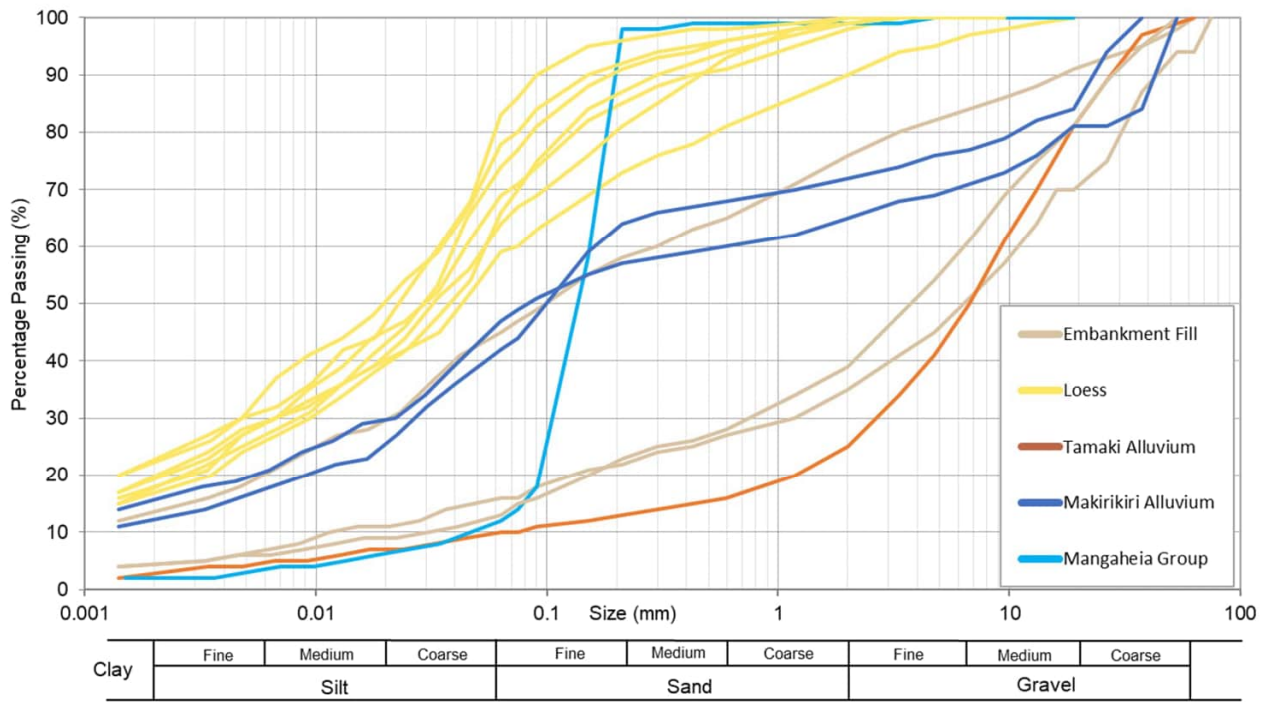
Figure 2-2: Particle size distribution curves for all samples.

Figure 2-2 shows the Embankment Fill and Tamaki Alluvium generally have 10%-15% fines (passing 0.075 mm sieve). Fell et al (2015) Section 8.5.4, suggests critical hydraulic gradients greater than 0.3 may be expected for material of this nature.

It should also be noted that whilst the Loess (and derived LPF liner and outlet pipe backfill) is not predicted to experience erosion into the TNZ F/2 filter material, the range of particle size distributions for this material presented in Figure 2-2 indicates it is possible some Loess may be fine enough to experience "some" erosion at this interface.

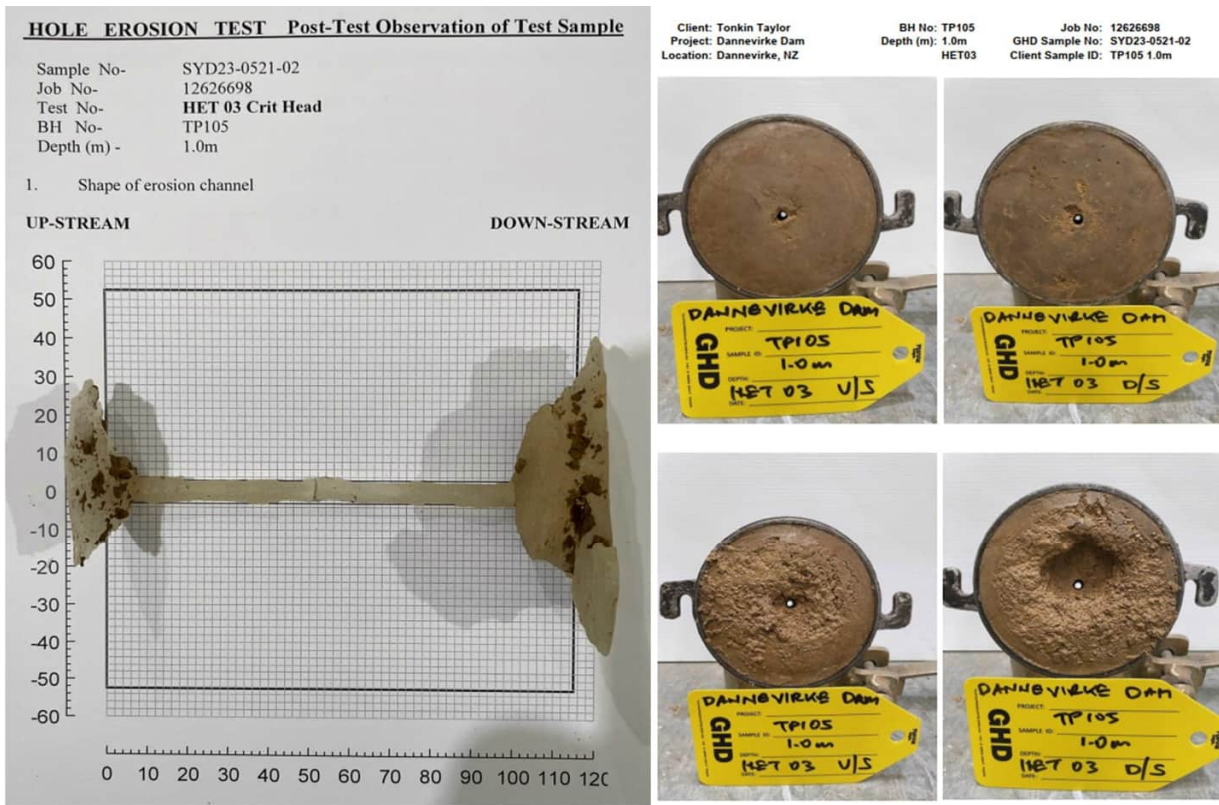
Figure 2-4: Example of post-test observations of a critical head HET on a remoulded sample from TP105 at 1.0m.

Standard and critical head Hole Erosion Tests (HETs) were carried out on two bulk samples remoulded to the respective optimum water content and 98% of the maximum dry density based on standard compaction testing. The tests were undertaken on Embankment Fill (BH01 at 8.6-10.1m) and Loess borrow material (TP105 at 1.0m) following test procedures after Wan & Fell 2002, 2004a and 2004b. Interpretation of the HET testing is presented in Appendix E.

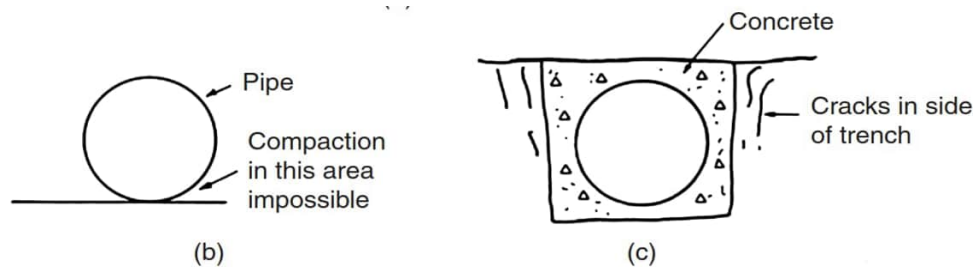
Figure 5-1: Causes of internal erosion around conduits due to (b) Inadequate compaction under the pipe, and (c) cracking in soil in the sides of the trench. Source: Fell et al (2015) Figure 8.19.

excavation and backfilling (see Figure 5-1 (b) and (c) respectively). These mechanisms are considered to represent the most likely mechanisms of concentrated leak erosion (excluding earthquake and post-earthquake conditions).

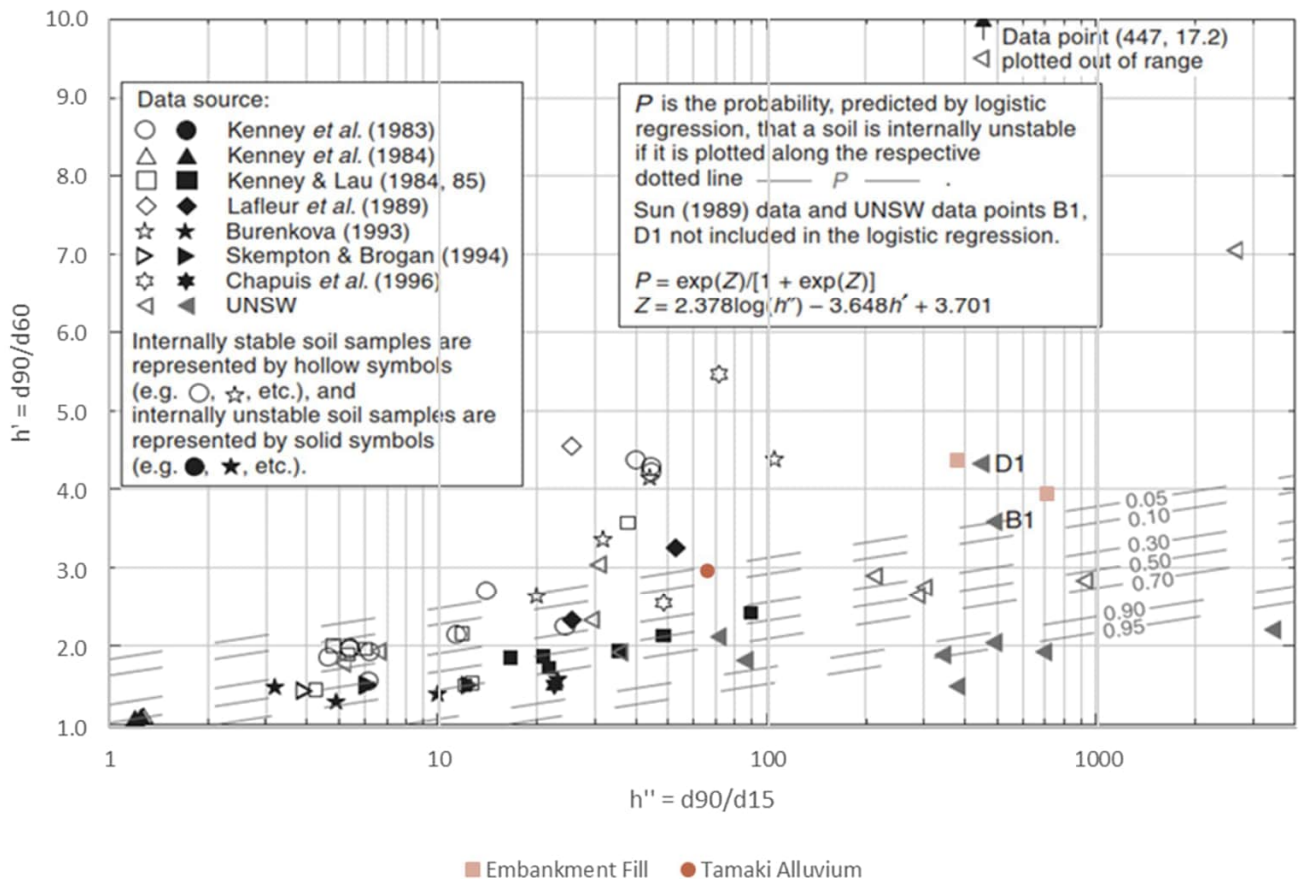
Figure 5-2: Probability of internal instability

The Wan and Fell adaption of the Burenkova method presented in Fell et al. (2015) has been used to assess susceptibility to suffusion. The material gradings presented in Figure 2-2 have been used to plot the probability of internal instability in Figure 5-2. The results are summarised in Table 5-4.
