Dannevirke Impounded Supply

Public Meeting
28 November 2023

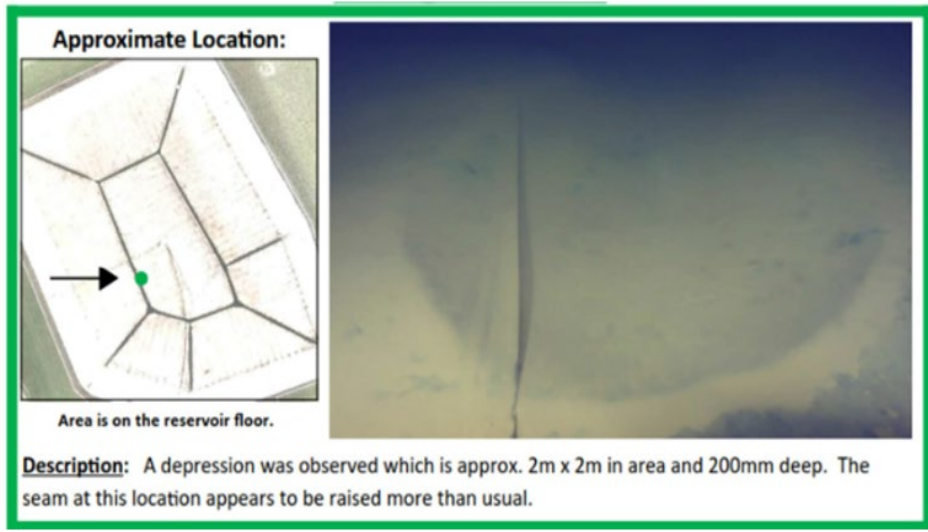
Initial Leak

- Subsoil outlet flows increased
- Reservoir level started dropping
- After floating cover removed, HDPE liner found to be “shredded” near the inlet
- The damaged liner below the inlet was repaired.
- ROV inspections found depressions under the HDPE liner:
 - On the slope below the inlet
 - At two locations on the reservoir floor
- Elevated level of water loss continued

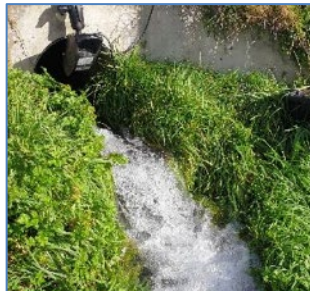
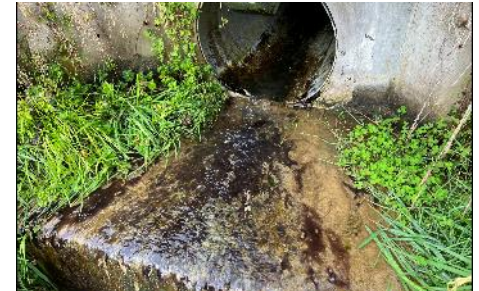
- Minor ongoing deterioration of internal depressions
- No deterioration of the eastern embankment (“dam wall”) identified
- Subsoil drain outlet flow has reduced from ~25 litres per second to ~3 litres per second
