## Dannevirke Raw Water Reservoir

Comprehensive Potential Impact Classification (PIC) Assessment

Prepared for  
Taranaki District Council

Prepared by  
Tonkin & Taylor Ltd

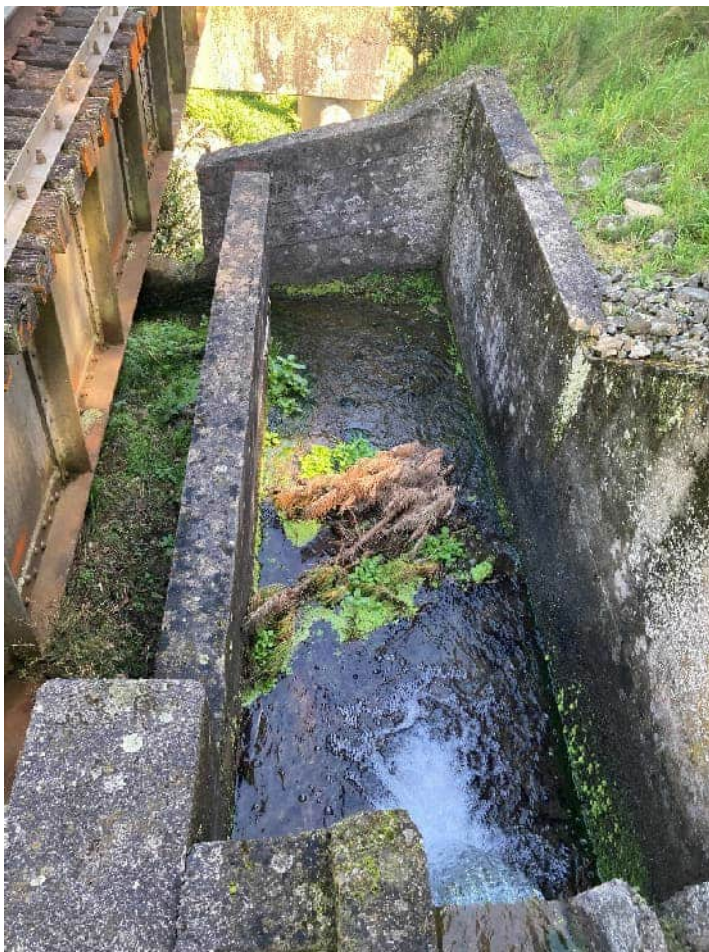
Figure 3.1: Photograph of drain north of rail bridge over Tamaki River

KiwiRail was approached to obtain information on the rail bridge over the Tamaki River. Photos of this rail bridge (KiwiRail reference 140 PNGL) and the approach cut section are shown in Figure 3.1, Figure 3.2, and Figure 3.3. The rail side drains close to the Tamaki River are concrete-lined and likely able to convey relatively fast flows without scour. As flow approaches the Tamaki River, it is conveyed from the drain on the northern side of the rail bridge to the concrete lined chute on the southern side, before entering the Tamaki River. The rail bridge appears to be piled.

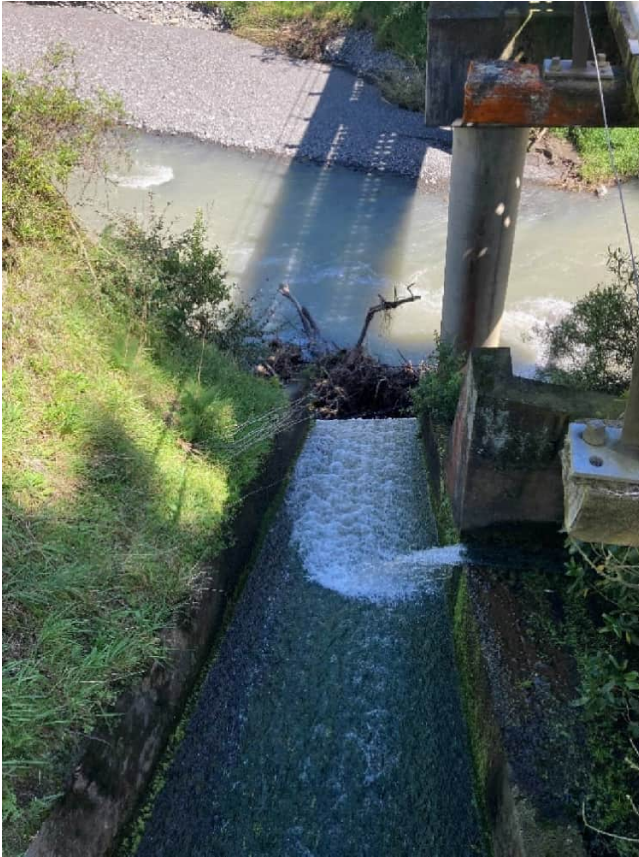
*Figure 3.2: Photograph of concrete lined chute south of rail bridge over Tamaki River*

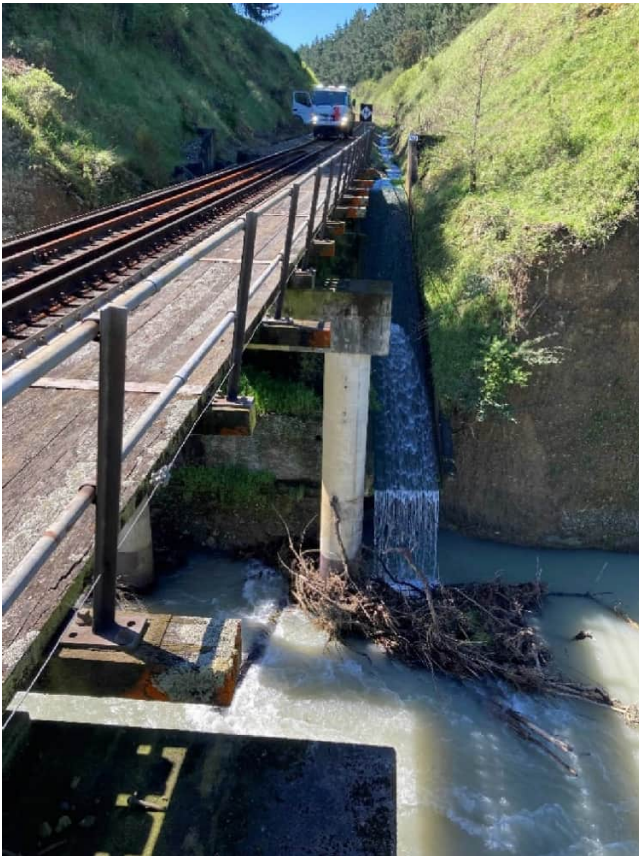
*Figure 3.3: Photograph of rail bridge over Tamaki River from true right*

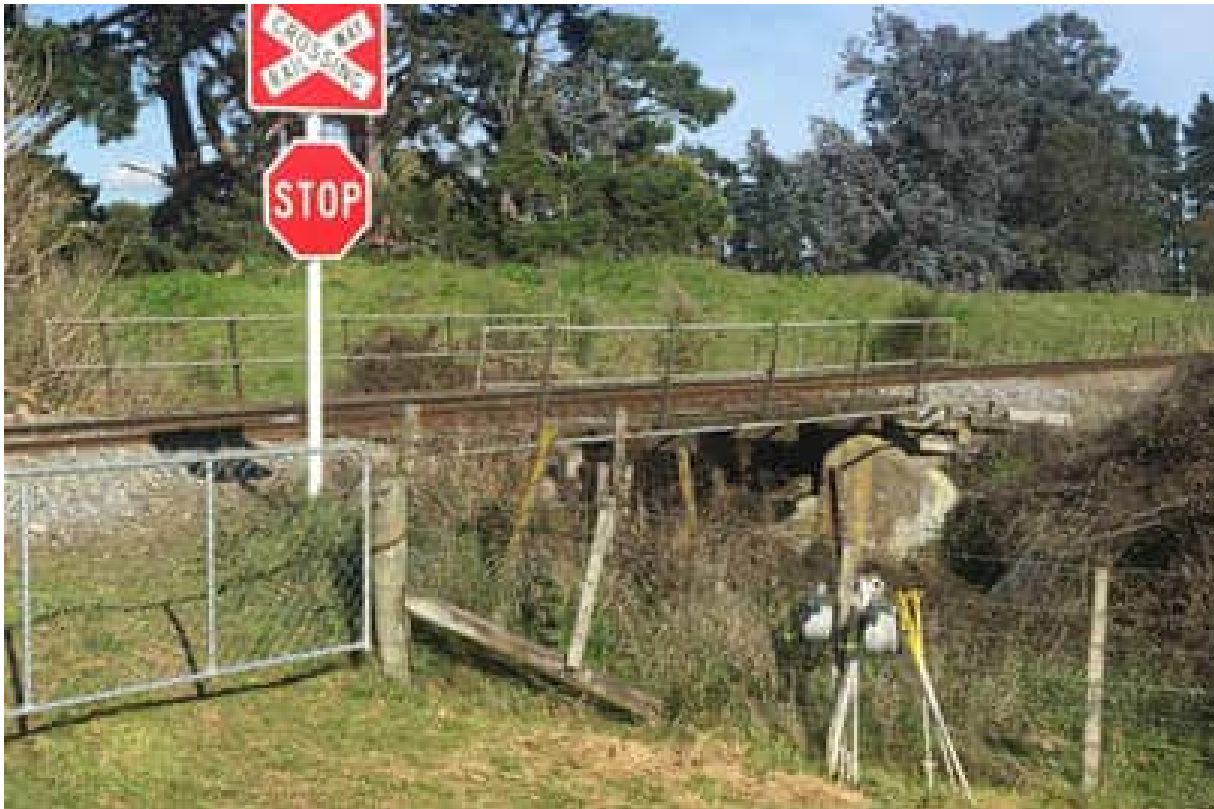
Figure 3.4: Photograph of rail bridge over Makirikiri Stream

We have also considered the potential for dam break flood damage to the Makirikiri Stream railway bridge. KiwiRail has provided the photo and dimensioned sketch of the rail bridge (KiwiRail reference PNGL 142) from an inspection in 2017 in Figure 3.4 and Figure 3.5. They have advised that they have no drawings on file.

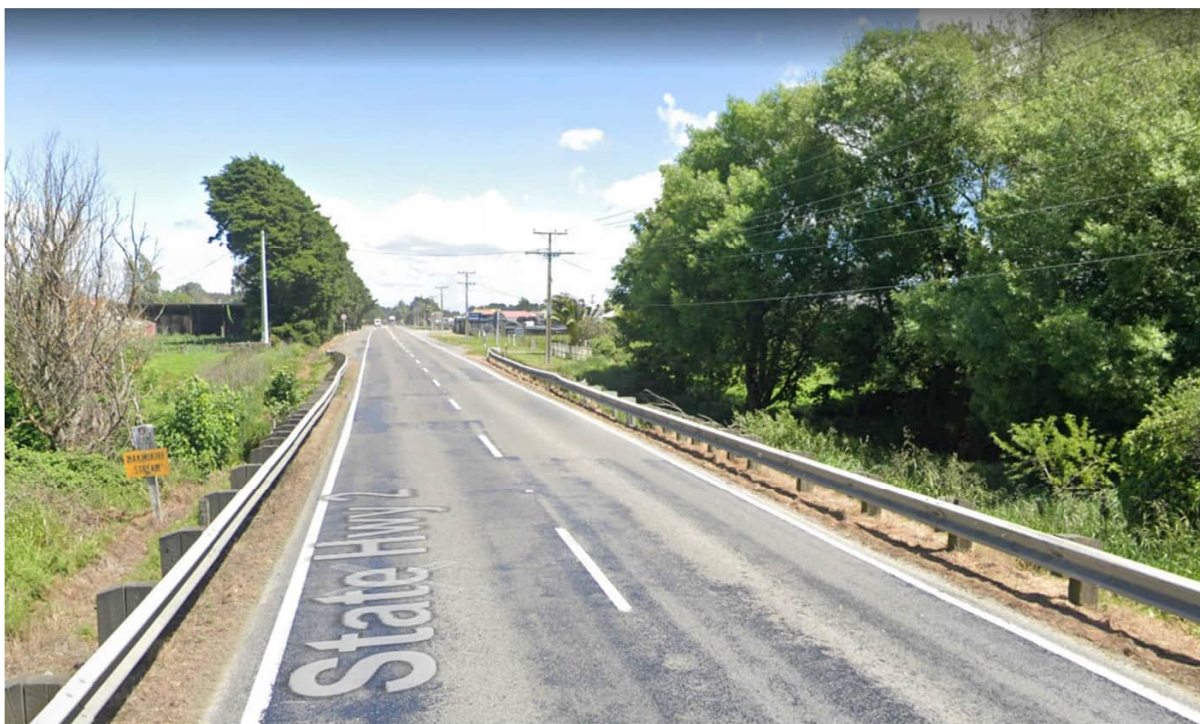
Figure 3.6: Photo of SH2 road bridge from Google Street View dated November 2022

We have also considered potential for dam break flood damage to the SH2 bridge over the Makirikiri Stream. A photo of the SH2 bridge from Google Earth is shown in Figure 3.6. WK NZTA has no as-built drawings nor hydraulic studies but has provided a drawing of scour repair works completed in the 1990s. Extracts from this drawing are included Figure 3.7. The repair works were undertaken because the stream channel was degrading below the bridge foundations. The works comprised construction of a reinforced concrete invert below the bridge. The downstream rock protection shown in the drawing was not constructed at the time to the best of WK NZTA's knowledge, but other rock protection was installed later.
